# Use of Imaging Techniques as a Support for the Preventive Conservation Strategy of Wall Paintings: Application to the Medieval Decors of the Château de Germolles

**Abstract.** Imaging techniques were used to document and monitor physical damage to the unique wall paintings at the Château de Germolles, Burgundy, France. Photogrammetry combined with scanning are the most appropriate techniques to monitor the evolution of microcrack networks in the cornice overhanging the paintings and preserved as a witness to 19th century additions.

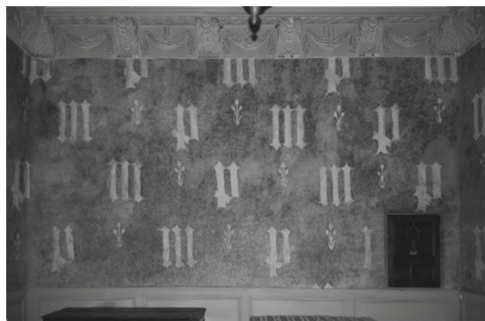
**Fig. 1.** Photograph of the west wall of Margaret of Bavaria’s dressing-room in visible light, showing the initials of the Dukes of Burgundy separated by thistles, © Papiashvili.

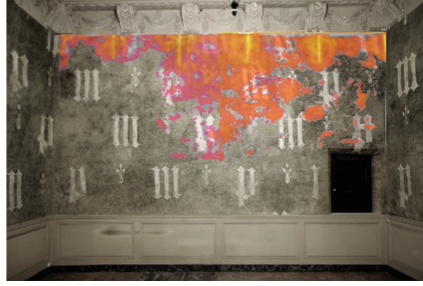
The documentation work carried out on the paintings also revealed significant physical damage to their upper part under the 19th century cornice. Figure 3 shows the areas of detachment between the painted plaster and the west wall of the Margaret of Bavaria's dressing-room quantitatively documented through IR thermography. The same damage was observed on the other three walls, of which only the east wall is interior.

**Fig. 3.** Distribution of areas of detachment of the painted plaster detected by IR thermography on the west wall of Margaret of Bavaria's dressing-room, © Tedeschi & Cucchi. (Colour figure online)

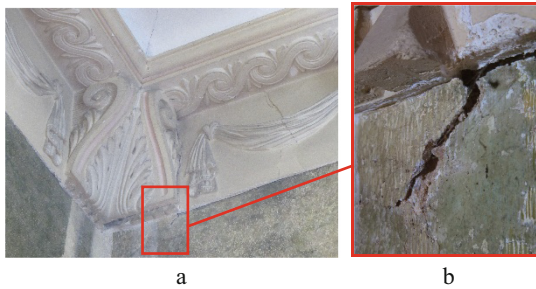
The 19th century cornice is also dotted with networks of cracks (Fig. 4a) resulting in other damage, including local detachment of the filling material used during the conservation intervention of 1989–1995 (Fig. 4b).

**Fig. 4.** Cracks in the 19th-century cornice and ceiling in the southwest corner of Margaret of Bavaria's dressing-room (a) and a detail showing a plaster filling detachment (b), © Germolles.

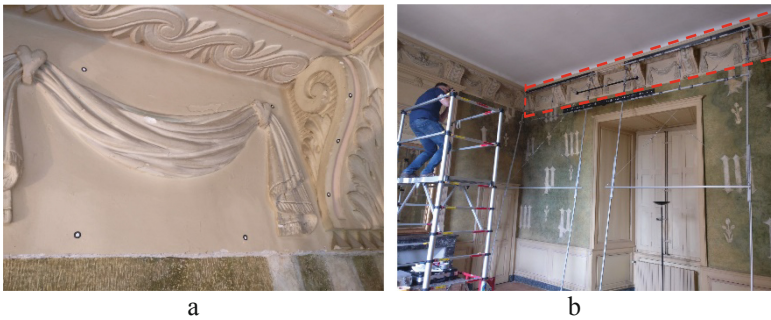
Fortunately, a few targets could be placed over the entire surface of the cornice providing a minimum of geometric information for data acquisition. As these have to be discreet and removed non-invasively, circular uncoded black and white targets of 1 cm diameter were used, glued with Paraloid B72 diluted in acetone. In order to prevent the latter from irreparably marking the plaster of the cornice when the targets are removed, a layer of cyclododecane, which sublimates in the atmosphere, was previously applied between the plaster and the adhesive. The targets are not referenced in a superordinate system (Fig. 5a).

**Fig. 5.** Target distribution on a cornice segment of Margaret of Bavaria's dressing-room (a) and photogrammetric campaign on the south wall (triangulated area in red) (b), © Germolles. (Colour figure online)

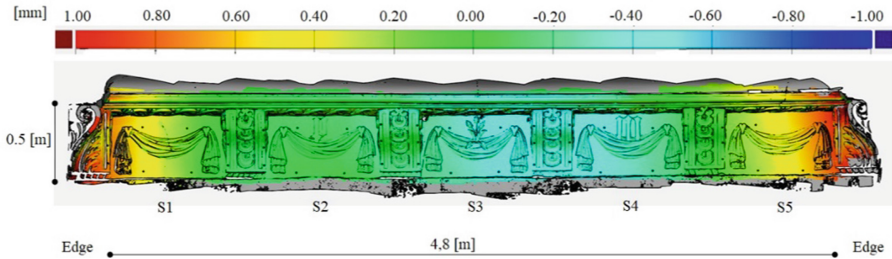
example for transformation results is shown in Fig. 7, comparing the 3D models of the summer and early autumn campaign (west wall). It shows clear global changes where the centre of the wall behaves opposite to the corners.

**Fig. 7.** Result of best fit transformation for two 3D models of the cornice of the west wall (campaigns 1 & 2), © i3Mainz. (Colour figure online)

Global deformations of the walls make it difficult to analyse deformations on the millimetre scale (at the level of the cracks). In order to answer the second question (are there local deformations), we analysed the individual wall segments (S1–S5 on Fig. 7 for west wall) separately. For this purpose, we applied a best fit transformation between two entire 3D models of an individual segment and visualized the results. As a visualization tool, we used 3DHOP and added functionality to display all difference models (from 1 & 2, 1 & 3,... up to 3 & 4).

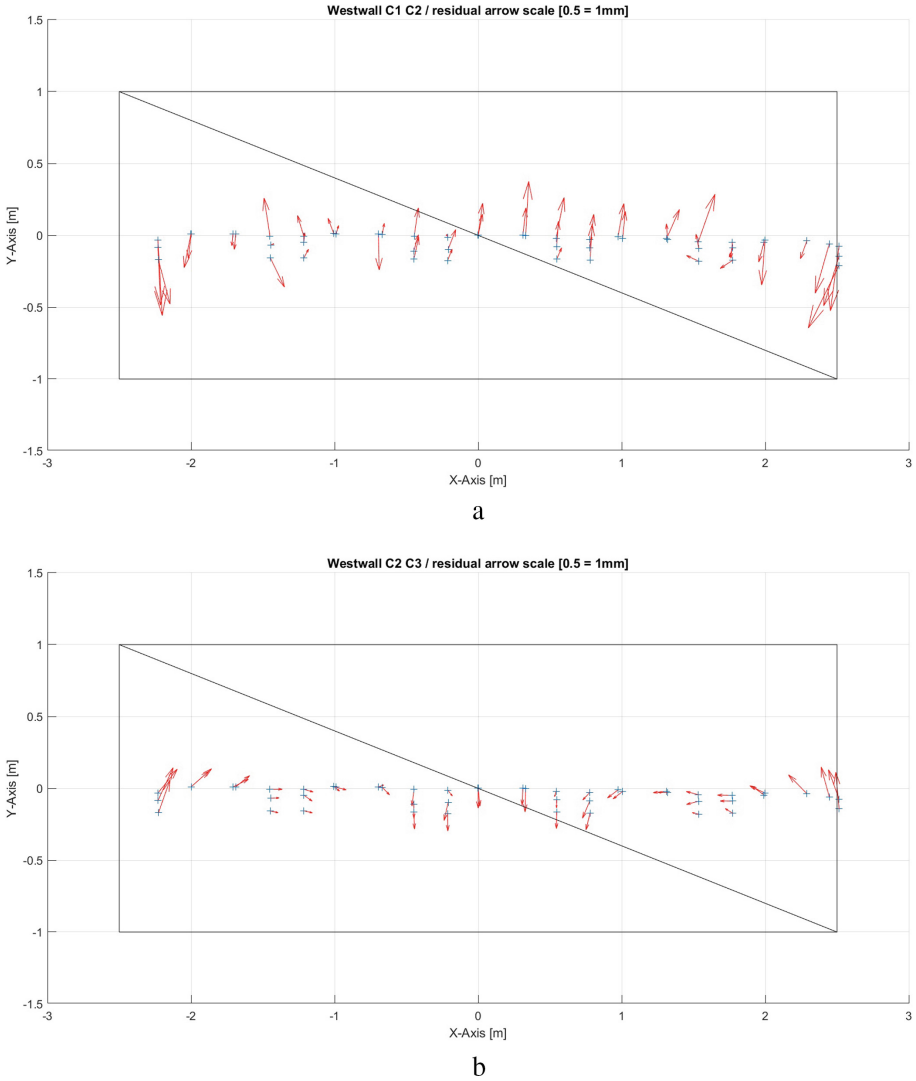
Further studies of these global changes use the field of target points transformed by means of a least square 6 parameter transformation. Figures 8a & 8b compare the results of campaigns 1 & 2 and 2 & 3. As in Fig. 7, we identify global changes from spring to autumn 2018 (1 & 2) and also from autumn 2018 to spring 2019 (2 & 3). As local trends are similar but in opposite directions, it appears that cornice movements are documented as small oscillations (less than 0.5 mm) where areas move back and forth.

**Fig. 8.** Visualization of the relative displacement of the targets of the cornice of the west wall of Margaret of Bavaria's dressing-room between the 1st and 2nd (a) and between the 2nd and 3rd campaigns (b), © i3Mainz. (Colour figure online)

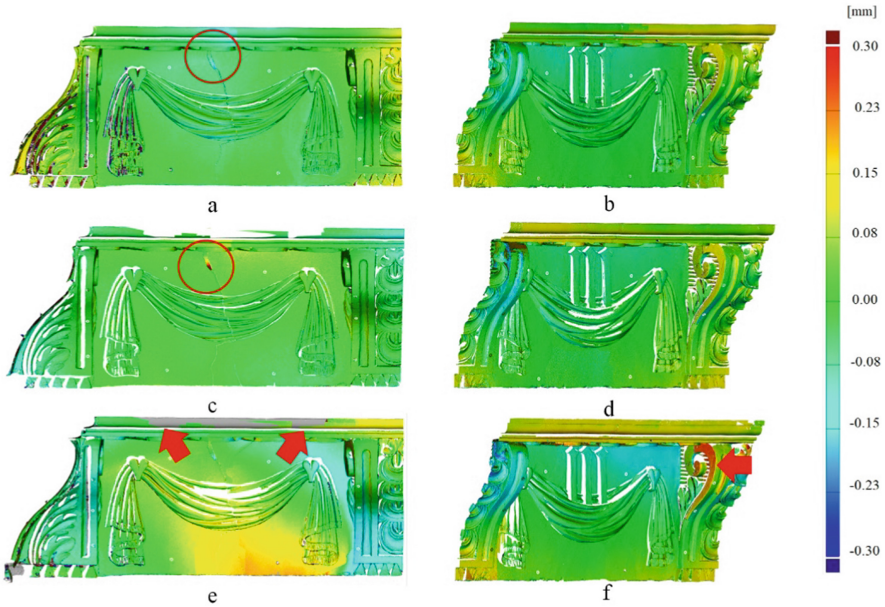
Figure 9 gives examples for the west wall (left side: S1, right side: S4). Figures 9a and 9c show that between scan campaigns 2 and 3, segment 1 of the cornice of the west wall of Margaret of Bavaria's dressing-room moved little, except in the area indicated by a red circle. In this wide crack, it appears that one of the fragments moved from the

inside to the outside. This movement is confirmed between scan campaigns 3 and 4 (Fig. 9e) but to a lesser extent and extends to the lower part of the cornice segment. Colour/uncoloured edges of the difference model (red arrows Fig. 9e) result from difficulties to access the area directly below the ceiling, resulting in less overlap of the scans. These side-effects are not documenting physical movements. A larger object movement is observed on the side of one of the volutes between campaigns 3 and 4 (Fig. 9f).

**Fig. 9.** 3D models of segments 1 and 4 of the cornice of the west wall of Margaret of Bavaria's dressing-room and comparison between scans 1/2 (a), 2/3 (c) and 3/4 (e) for segment 1 and 1/2 (b), 1/3 (d) and 1/4 (f) for segment 4, © i3Mainz. (Colour figure online)

These expansion and contraction movements remain minimal (max. 0.5 mm) but cause local damage of some cornice segments, especially those that are already partially detached or near major cracks. It is interesting to note that the cornice of the west wall seems to be the most affected as shown in Fig. 9 but also with its important network of cracks. The cornice of the south wall, which is under great stresses, is less affected. Its movements, however, have an impact on the adjacent cornice elements, that of the west wall as seen above, but also that of the east wall less stressed but very much affected as shown again by the extensive network of cracks.
